# GLASMALEREI PETERS STUDIOS

Studios for restoration and preservation of historic monuments

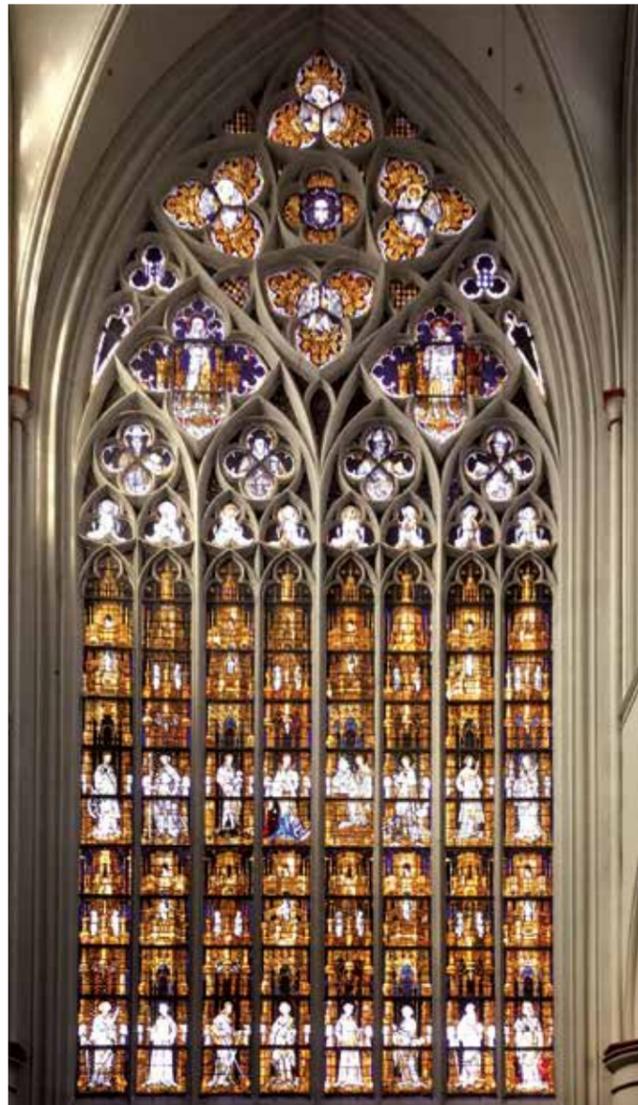
8 West window, c. 1390

Originally, only a gentle dry brush cleaning and the edge-bonding of cracks was planned for the west window. However, during the scientific investigations, it was discovered that a large number of harmful micro-organisms were present on the glass surfaces. These microorganisms exacerbated the damage already present on the painting layer and glass.

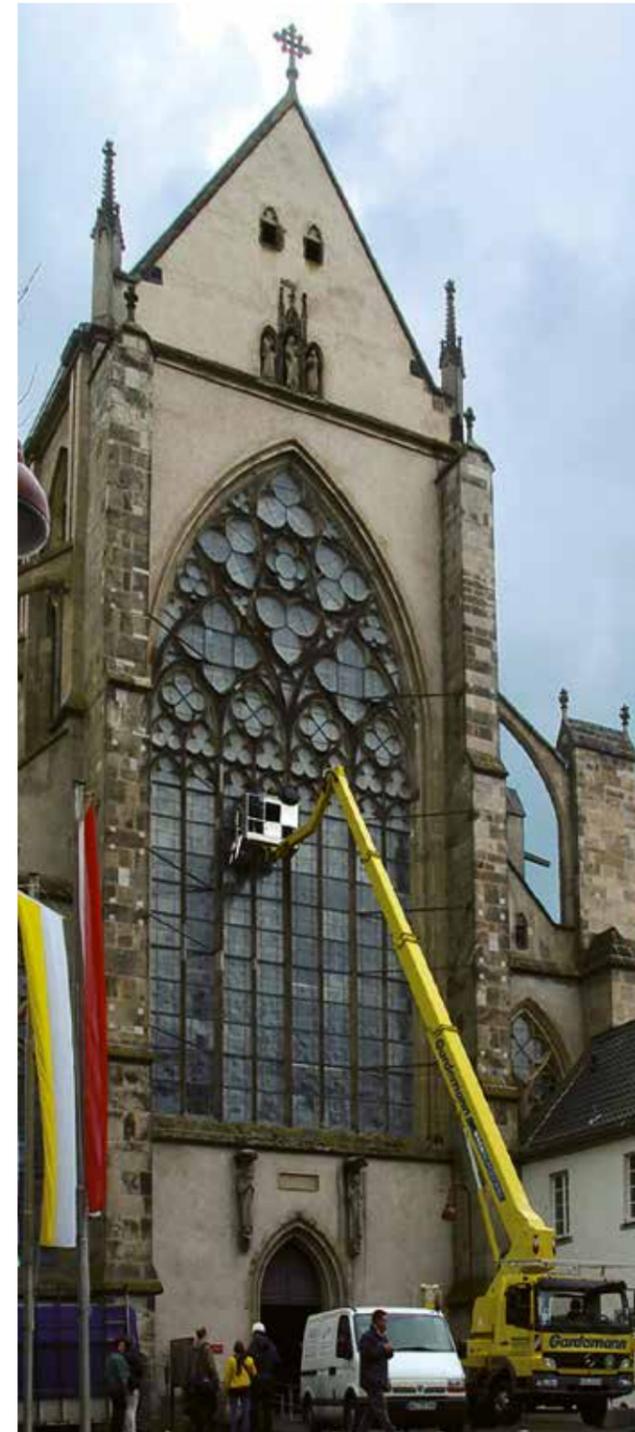
Attaching the glass sensors to the outside of the protective glazing

In order to monitor the effectiveness of the protective glazing in the long term, glass sensors were installed on the outside and inside and in the interspace in cooperation with the Fraunhofer Institute for Silicate Research. The influence of moisture, temperature changes, pollutants and microorganisms at the point of use is quantified at the glass sensors in the laboratory by IR spectroscopy and recorded with a simple numerical value (E-value). The protective glazing must meet not only functional but also aesthetic requirements. In the case of Altenberg Cathedral, the protective glass was therefore coated with a matt layer of paint on the outside in order to artificially imitate the missing patina. In addition, it was decided to incorporate the lines of the original panels as a lead net into the protective glazing. In this way, it was possible to approximate the original exterior appearance of the cathedral and its windows. This protective glazing at Altenberg Cathedral is an example of visually successful glazing which, with its geometrically simple forms, blends unobtrusively into the exterior appearance.

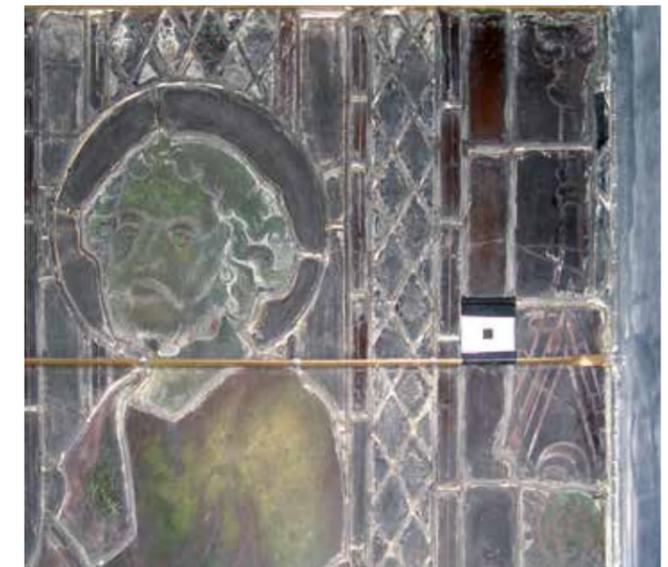
Fig. 1 - Glass sensor on the inside

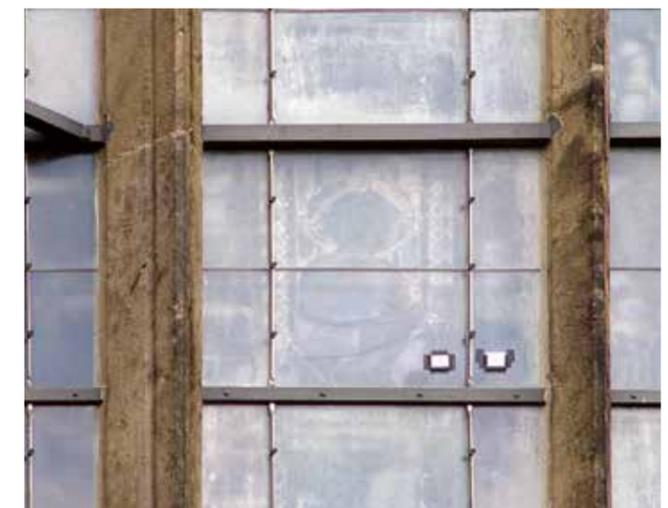
Fig. 2 - Glass sensor on the outside

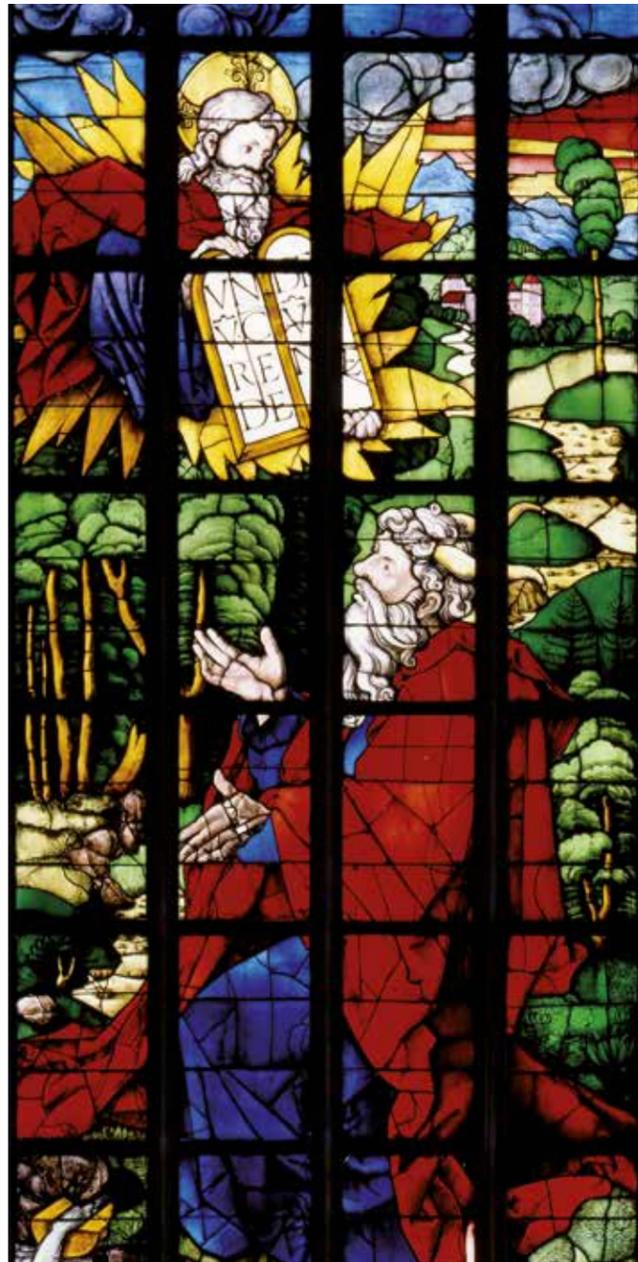
Moses window, after a design by Albrecht Dürer, c. 1498

Numerous cracks had appeared on the Moses window. The interior surfaces were covered with a layer of soot and dust on the one hand and contaminated by a brownish deposit on the other. This was a microbial infestation of the surfaces, present to an alarming extent. On the outside, the window was heavily soiled with pigeon

Extremely serious damage was found on the paint layers. The black grisaille paint applied in several layers had loosened in places and was detaching from the glass surface. The main causes of the progression of damage were thought to be the condensation on the inside of the original panels and the increasing changes in humidity and temperature. Other reasons for this damage to the paint layers could also be the use of unsuitable restoration materials or subsequently applied coatings. To verify the causes of the damage and as a basis for drawing up an individual conservation concept, samples were taken and sent for analysis.

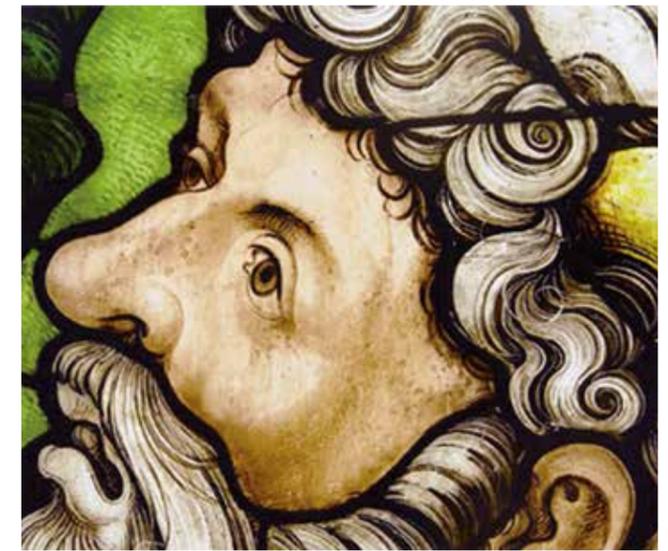
Moses' head without retouching - condition today

A virtual retouching was made on the detailed section of Moses' head on the basis of the photograph from 1943 and the actual 3-D-Scan.

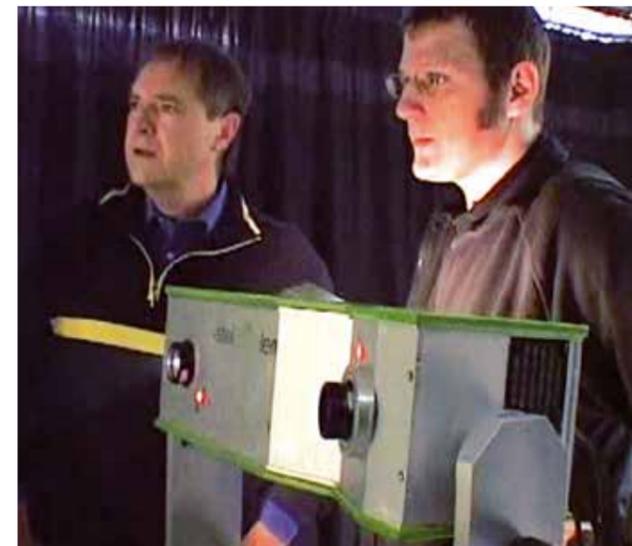
3D-Scanner - Zusammenarbeit mit der Universität Bamberg

was the usability of the documents for future damage monitoring. The method considered was non-invasive 3D white-light strip projection, with which the topography of surfaces can be recorded without distortion and geometric data for grisaille paint-based glass paintings are highly informative despite their colour neutrality. By comparing the status quo with older photographs, chronological analyses can be made from which material losses or the occurrence of deformation and stress cracks can be deduced. Another benefit of the method for some types of glass is the detection of surface defects and the visualisation of fire residues or optically conspicuous corrosion layers.

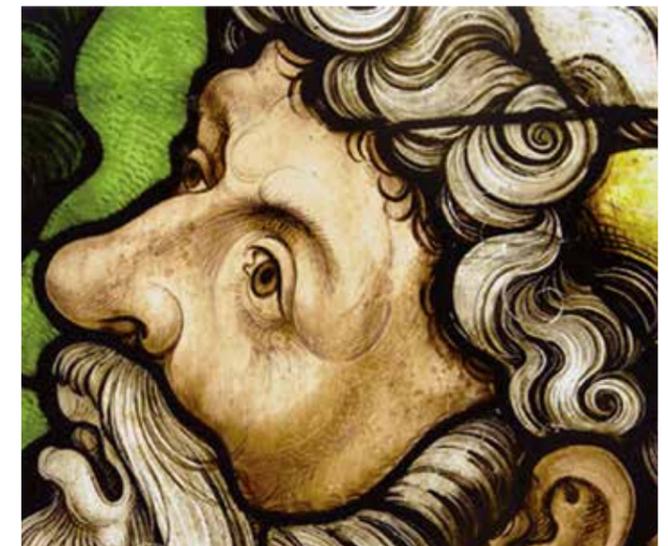
Moses head with heavy retouching, approx. 100% possible condition in the period of origin. All hatching lines are not clarified.

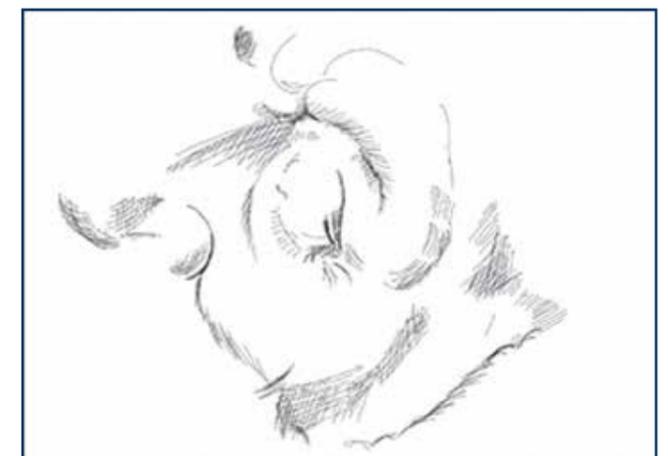
Retouching approx. 100%

This opens up two perspectives: On the one hand, the 3D data sets are suitable for objective monitoring of deterioration. On the other hand, the superimposition of the 3D data with older photographs allows the reconstruction of lost layers of paint in favourable cases. This can be important in the case of scientific questions and reconstructive restorations. Even beforehand, the photographic comparison of the status quo of the window with older photo cycles showed a clear loss of contour lines.

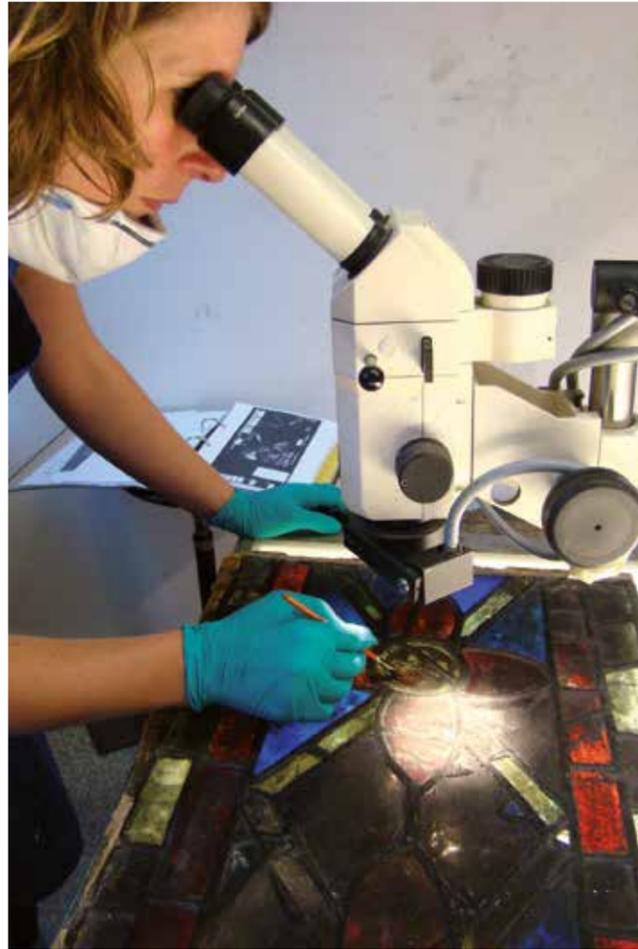
Cleaning under the microscope

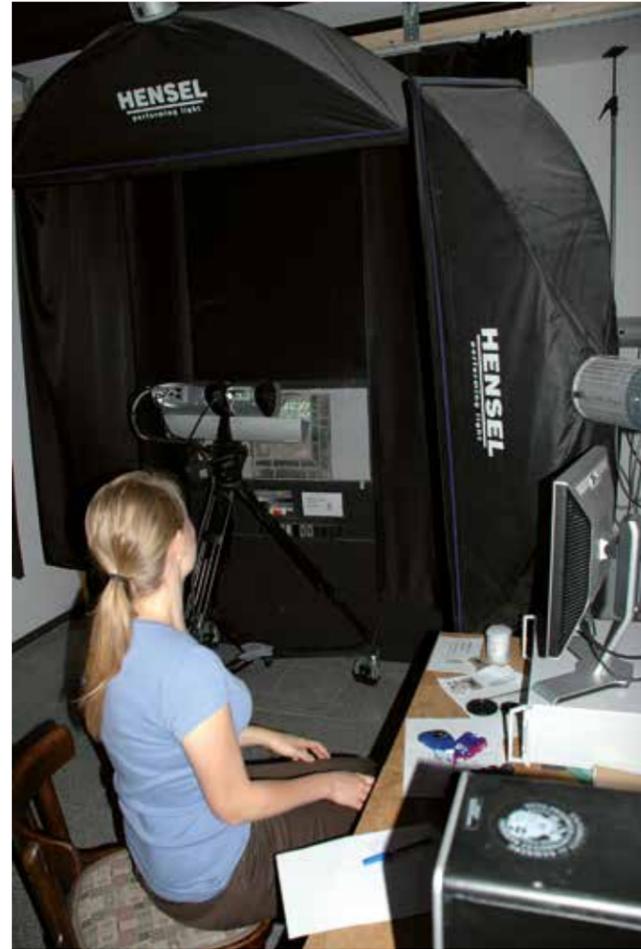
Creation of a 3D white light scan

As an example, a 3D white light scan was also carried out on one panel. In cooperation with the University of Bamberg, this device was tested for topographical surface analysis in order to obtain detailed information about the removal of dirt and corrosion layers and, if necessary, to make lost painting visible again.

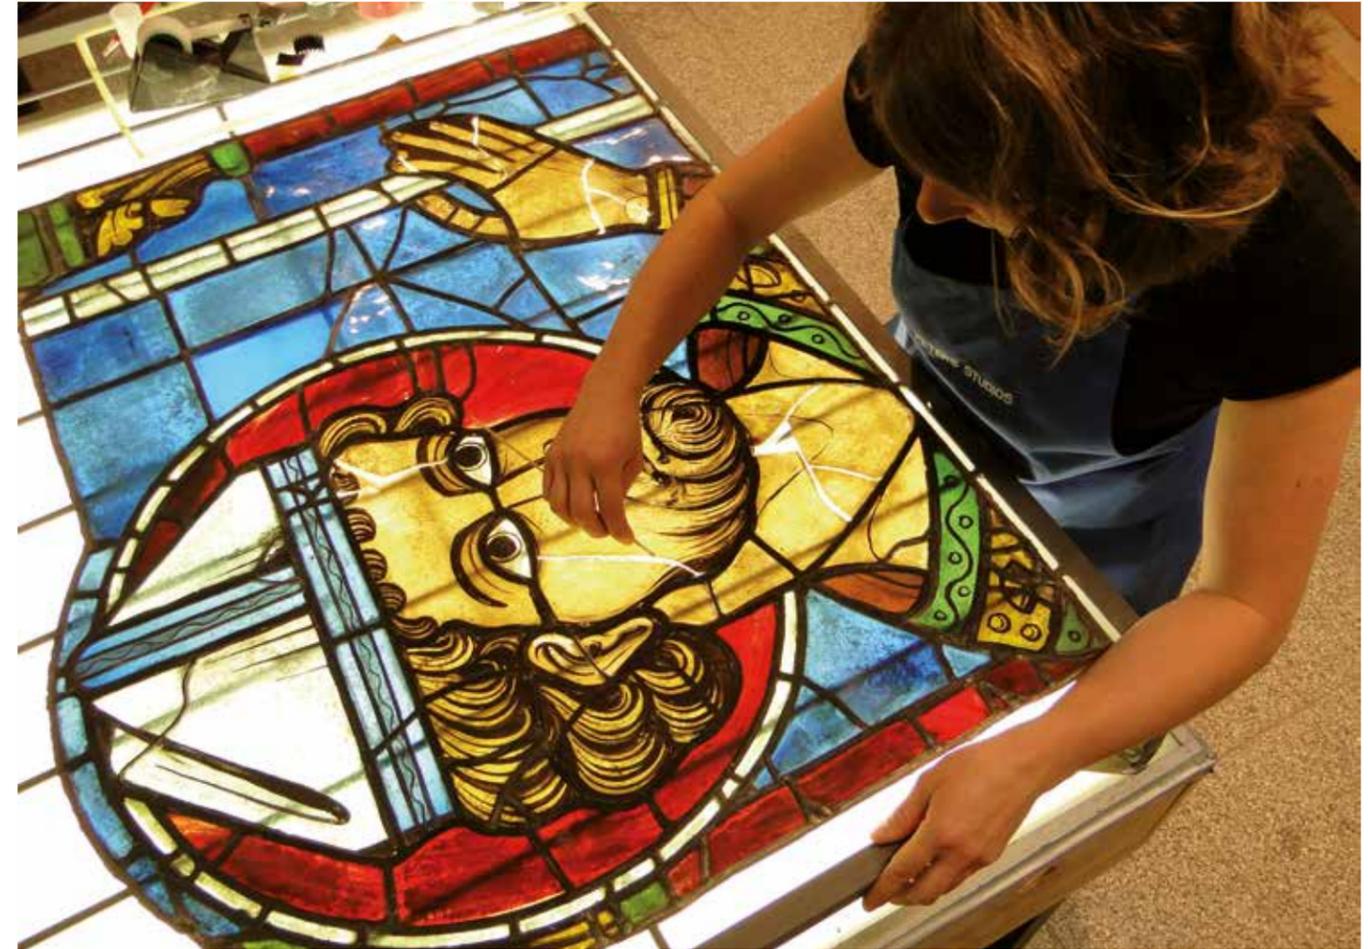
Removal of the mending leads and edge-bonding of the cracks

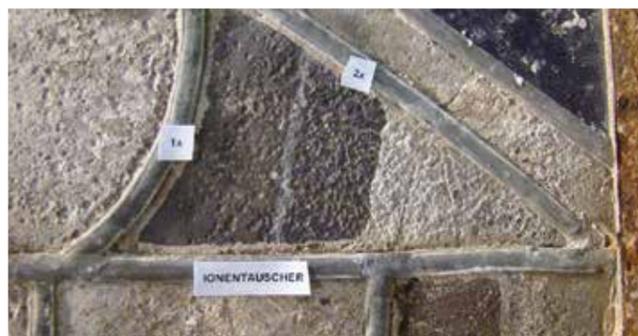
14 Reinigung mit Ionentauscher

sive methods. Due to the composition of the corrosion product, it was possible to convert the corrosion crusts into an easily soluble product that could be lifted off with simple plastic spatulas

The advantage of the ion exchanger is that no aggressive solvents are applied to the historic material and the process is completed immediately after the batch is removed. The ion exchangers used are a resin that is applied in solid form and activated by distilled water. The process can be precisely monitored and controlled by the solid application form. Other agents such as EDTA, on the other hand, can be reactivated by condensation in the form of dried residue on the glass, causing further damage to the glass. The cleaning method we used, on the other hand, is absolutely risk-free and thus optimal from the point of view of monument preservation.

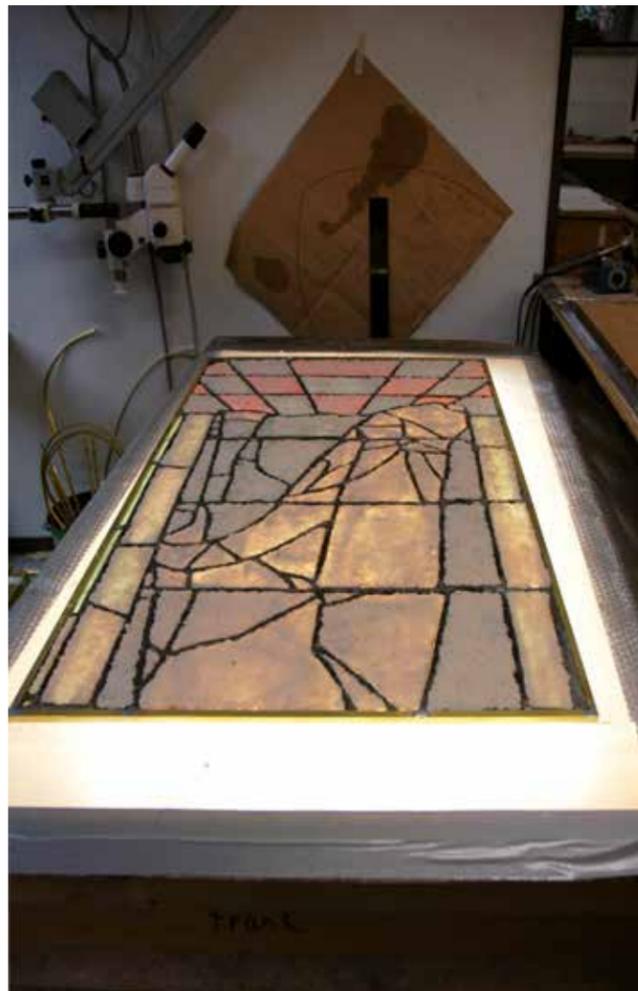
16 Covering the glass surfaces

Ion exchangers are organic solids with a high surface area in the form of beads or crushed as powder. They are a water-insoluble, three-dimensional, high-molecular framework. Firmly attached to this so-called synthetic resin matrix are anchor groups with loosely bound counterions, which are readily exchanged for the ions of a liquid phase.

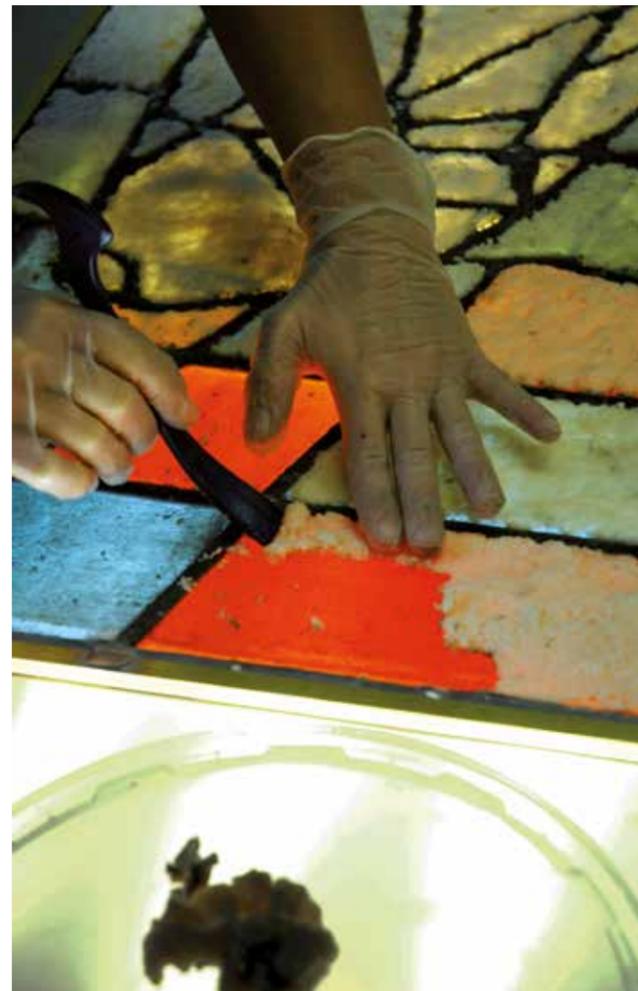
Removal of the compresses

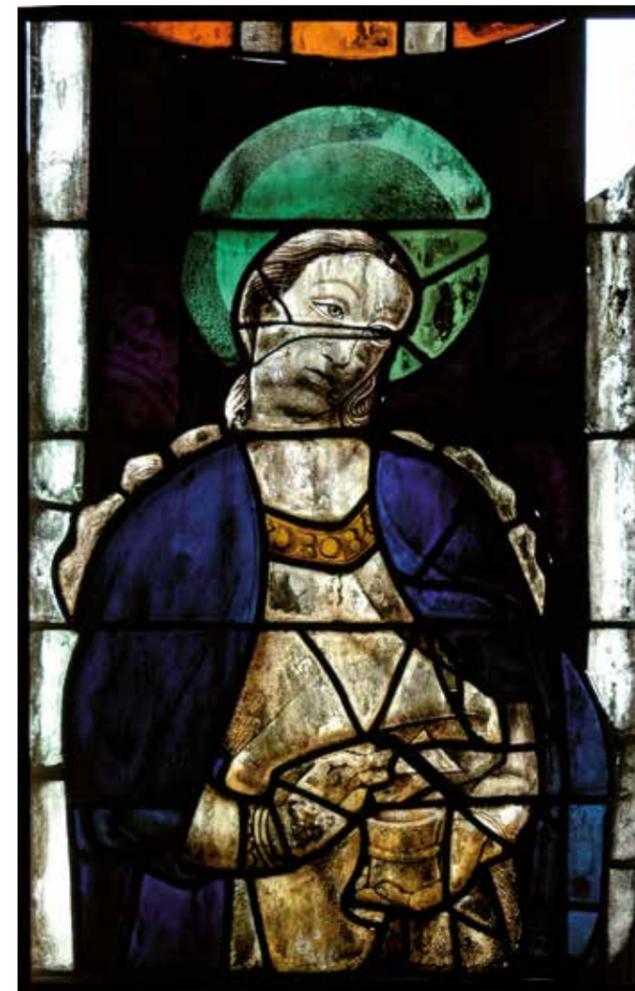
Panel in transmitted light - before cleaning

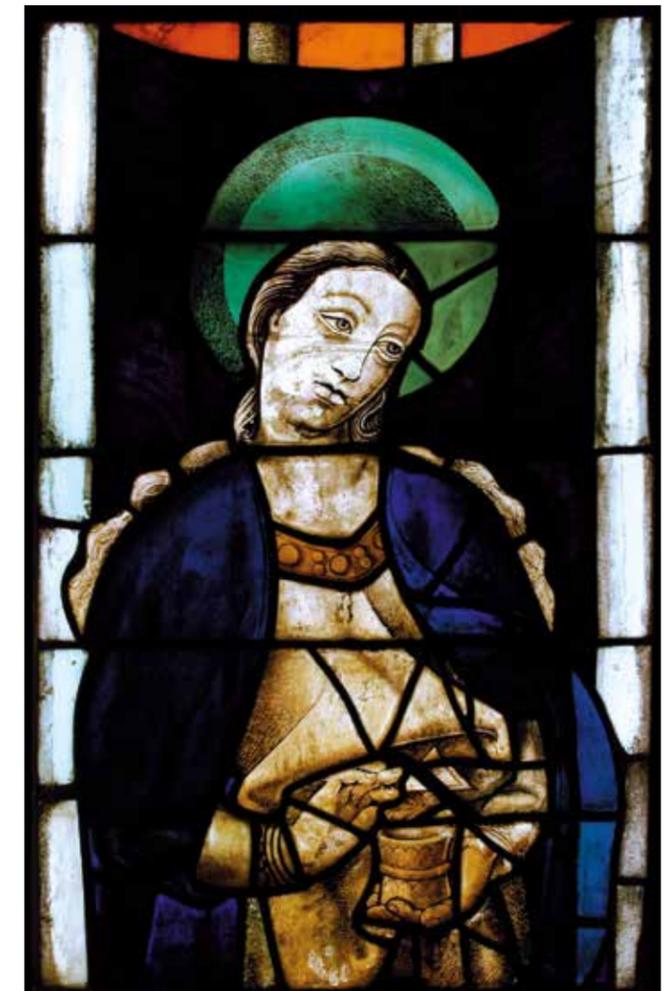
Window in transmitted light - after cleaning

The cleaning result was very successful. The tension-rich layer was removed without damage and the theological message of the windows was clearly legible again.

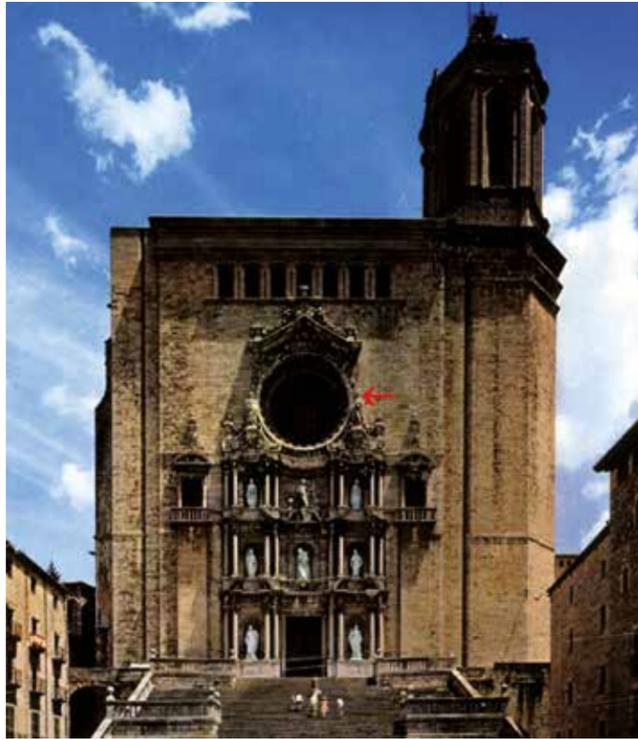
West portal with rosette, diameter approx. 8 m

The rosette windows were for the most part original, apart from a few panes of repair glass and a panel in the east rosette that was inserted later. On both rose windows, there were a large number of cracked panes and, in some cases, missing pieces of glass. There was conspicuous surface damage in the form of a grey haze that appeared exclusively on the violet glass. Most of the painting was very badly damaged due to the loss of adhesion. In large areas, the paint layer had peeled off over a significant area and the original design could only be seen at close range and under raking light. The missing paint had an aesthetically disturbing effect, especially in the figurative areas. The missing areas were so prominent that the legibility of the window was severely compromised. Therefore, it was decided to recreate the lost painting. Various proposals were developed and presented for this purpose. In consultation with the responsible monument conservators, the scope and type of execution were determined in detail. The additions were to be designed in such a way that they were reversible and also easy to remove.

plied in grisaille paint to a separate clear glass pane which was then fired. During assembly, these panes were then mounted in a package with the corresponding original glazing, which was thus restored to legibility in transmitted light, but without altering the original substance. The supplementary clear glass pane can be removed at any time with little effort. Both rose windows have also received internally ventilated protective glazing.

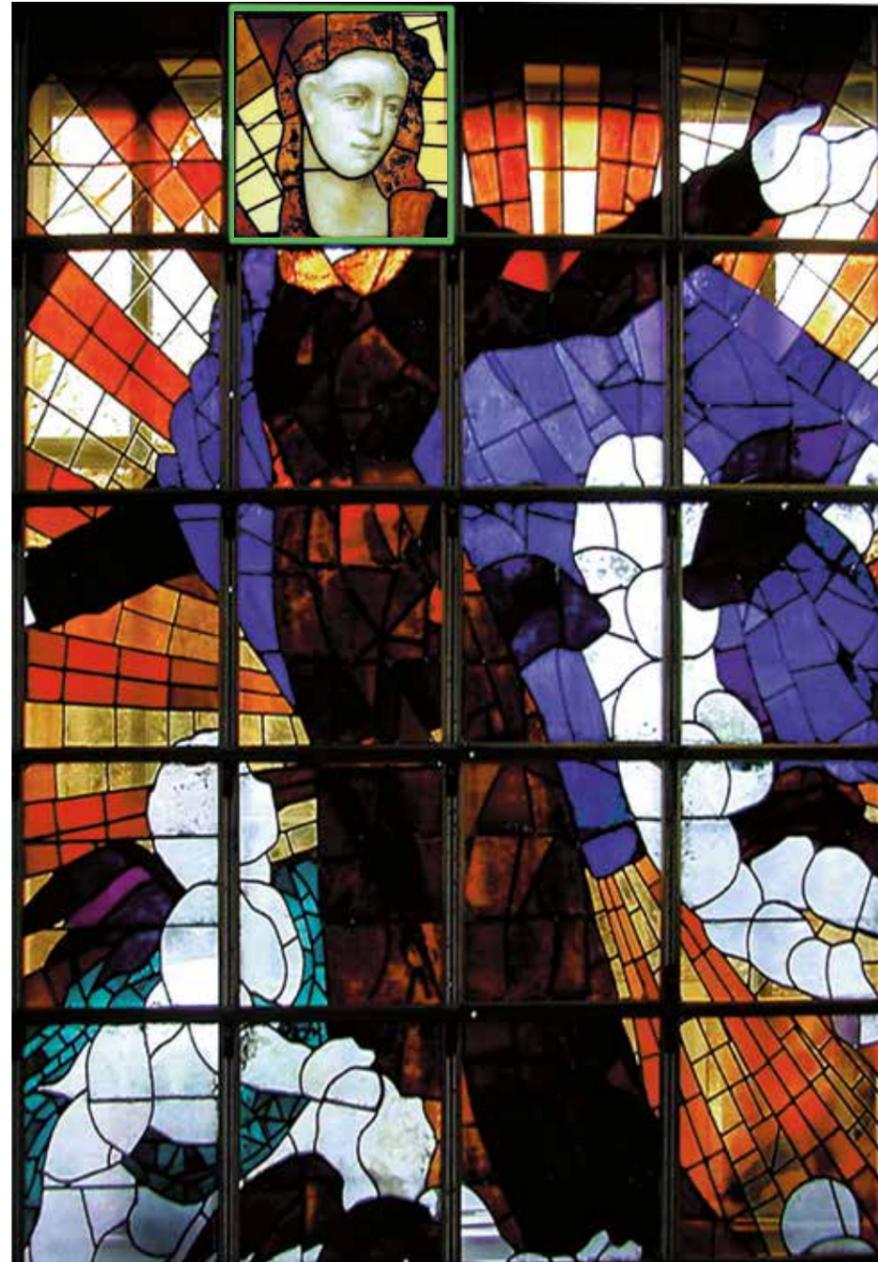
Original and doubling pane

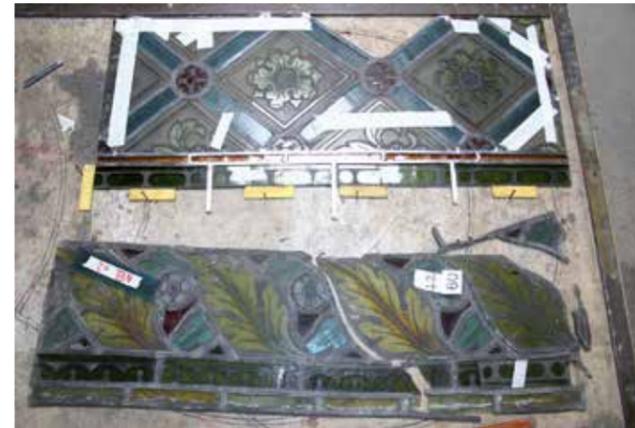
Assembling the fragments in the workshop

The decision was made to restore and partially reconstruct the nineteenth-century windows with the help of the remaining pieces found. A concept was developed in close cooperation with a local architect and the responsible monument preservation authority and executed in our workshop.

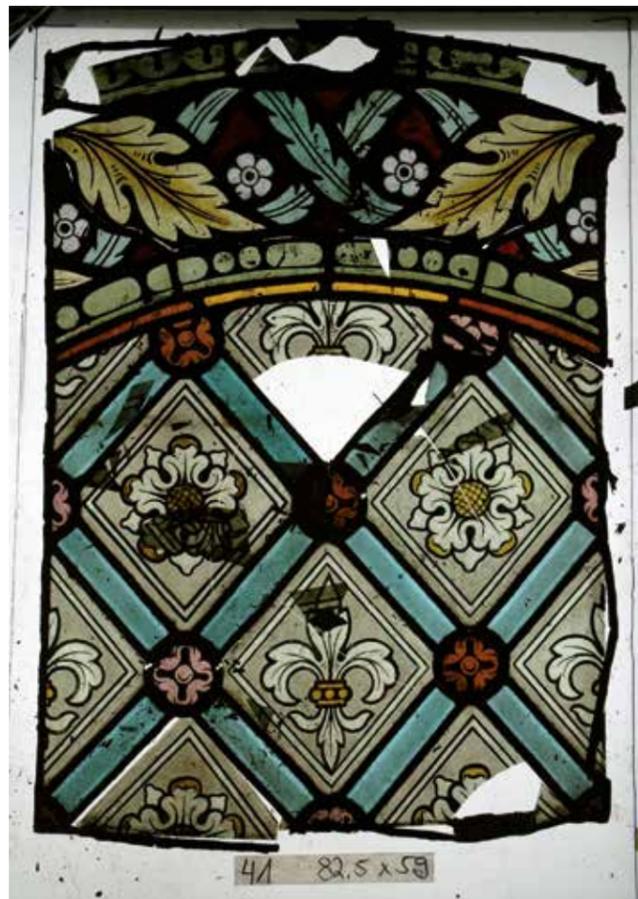
Before the restoration

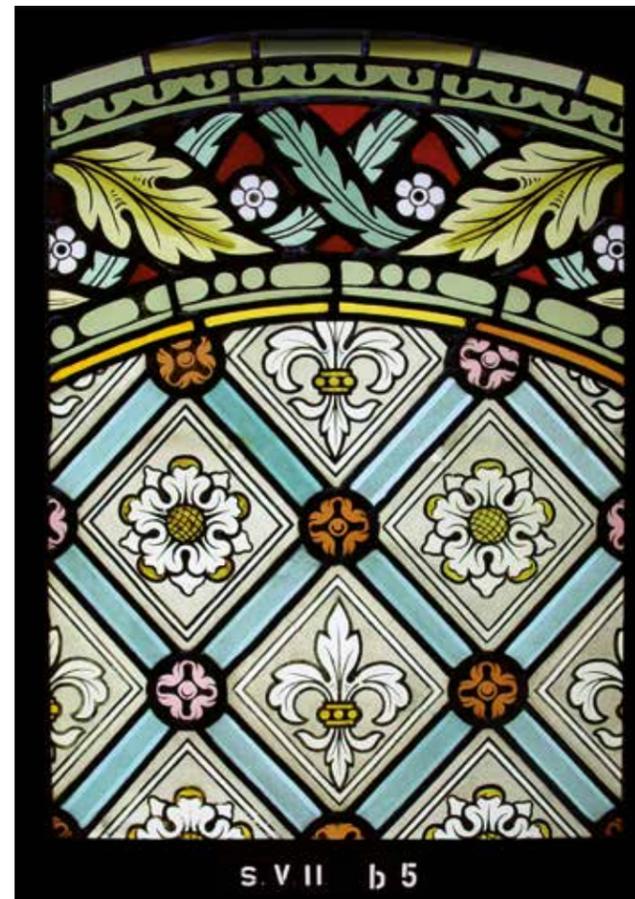
After the restoration

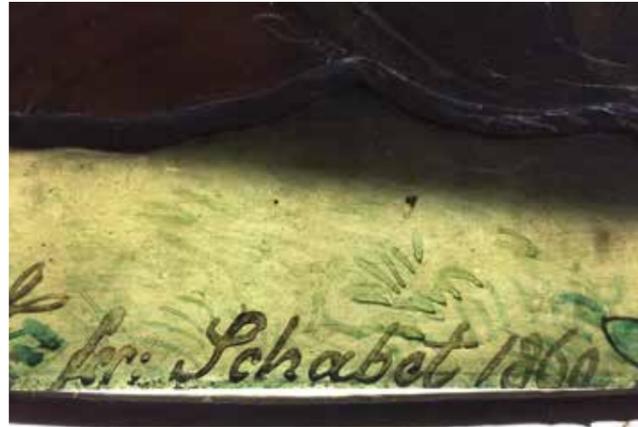
Signature of the artist „Schabet 1860“ in the window

In this way, it was also possible to clearly establish the connection with the southern window still remaining in the choir, which is signed „Josef Dopfer’s Glasmalerei in München“ and bears the date 1862. By consulting historical photographs of the church

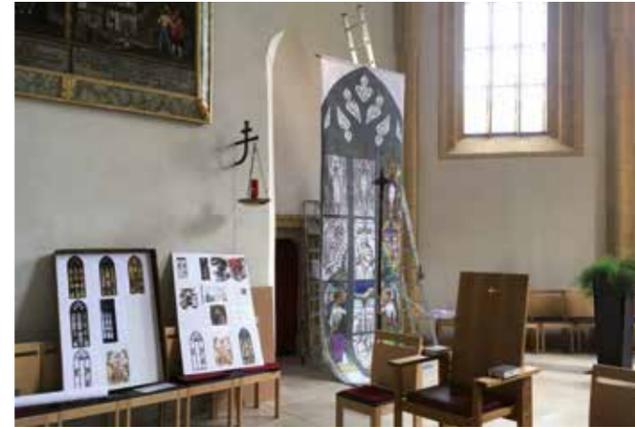
Discussion of the reconstruction drawing in the church

The archive documents collected and the parallel search for the still-missing window fragments made a reconstruction drawing of the missing elements possible as a first step. The axial symmetry of the window facilitated the reconstruction and provided certainty for the design of the missing parts.

The study of the restored window fragments, which showed the high quality of the paintings by the artist Schabet, in connection with the reconstruction drawing made on a 1:1 scale, formed the basis for decisions by the monument conservation department and the episcopal art and building commission, which led to the overall reconstruction of the window. The aim was to make the additions as close as possible to the original, in order to re-establish a coherent overall impression.

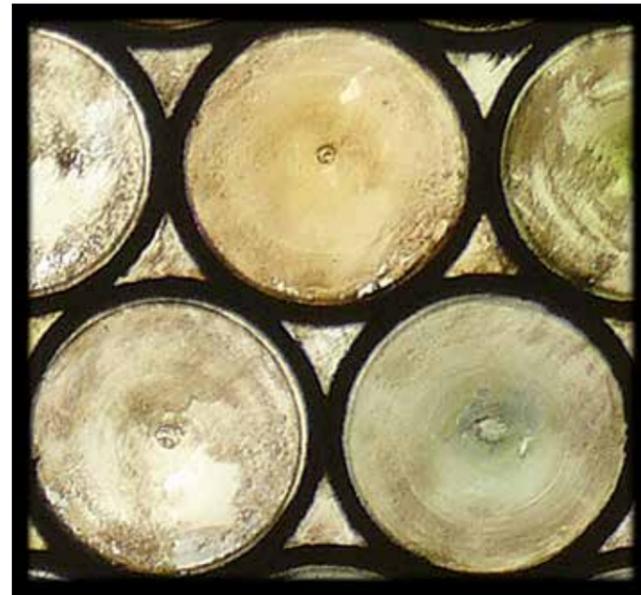
Original panel - detail

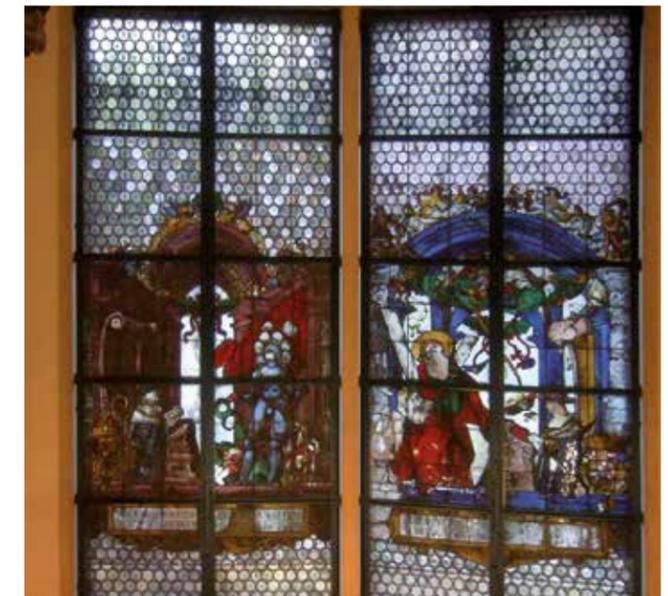
Original panels and additions after reinstallation

In order to fulfil these requirements and to find a didactically correct connection, we took high-resolution photographs of the preserved rows of Butzen and assembled them into a new panel. This overall panel was then processed into a dot grid and transferred to the panels by means of screen printing. By including the signs of ageing on the Butzen, the panels took on a special, independent life and were able to coexist with the original. However, during the first trial fitting it was noticed that the lack of colour of the new panels made them stand out, so a colour adjustment to the original was made using an airbrush.

The result is a harmonious overall picture without separation, yet old and new are clearly separated from each other, because the addition bears the craftsmanship of our time and does not aim to copy or forge.

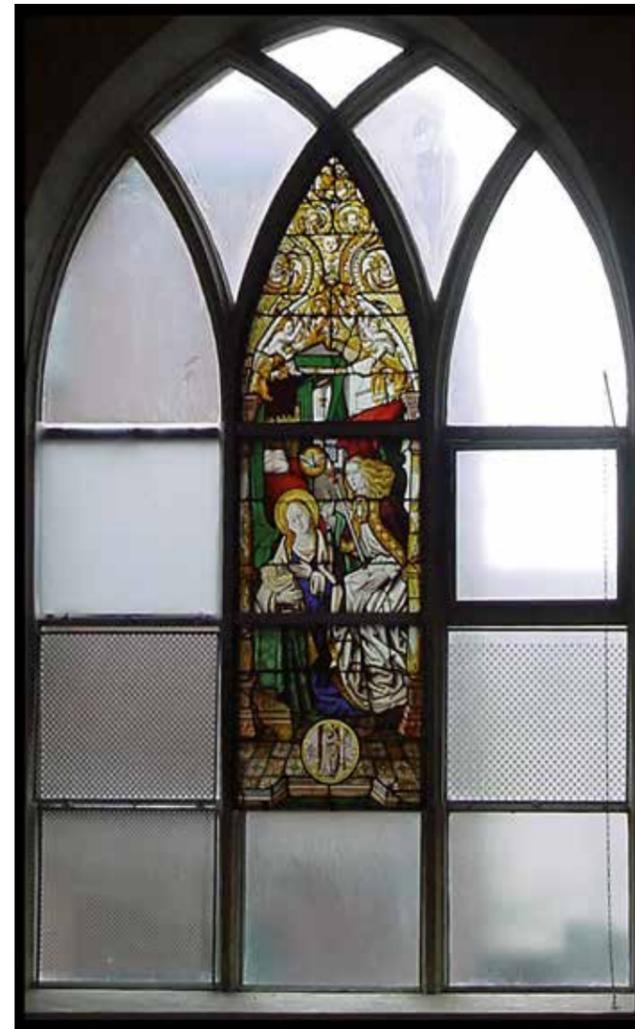
Various grid samples on site

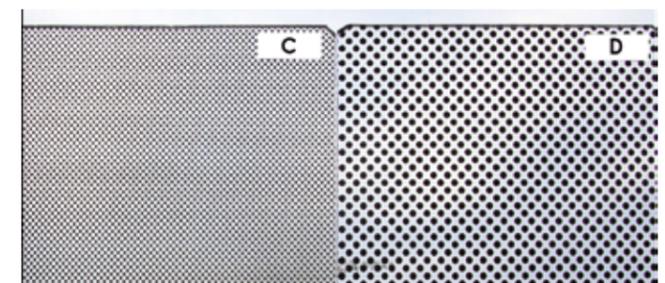
Grid samples in different sizes

Another reason for these measures was that the church was also to be used as an exhibition space, so the interior needed to be given a calmer light. The newly created glass environment of the Renaissance fragments was darkened by means of screen printing discs in such a way that the middle grey value embeds the historical fragments in the overall picture without competing with them.

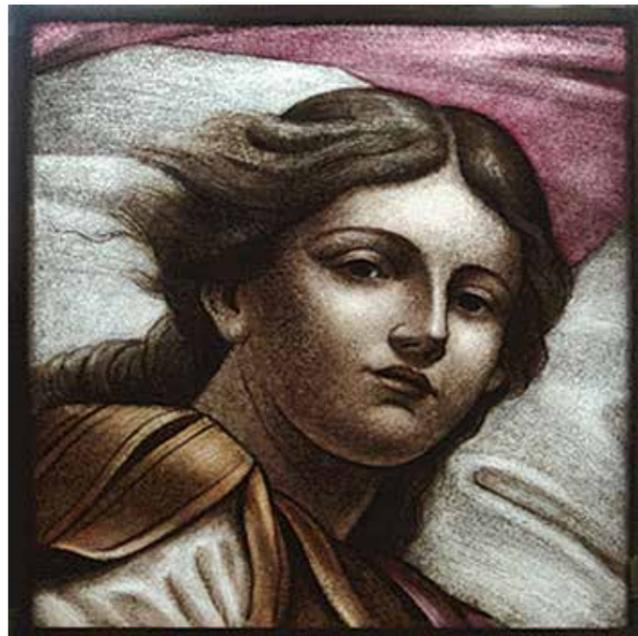
30 Hand-painted with black grisaille paint, overlays and enamel colours

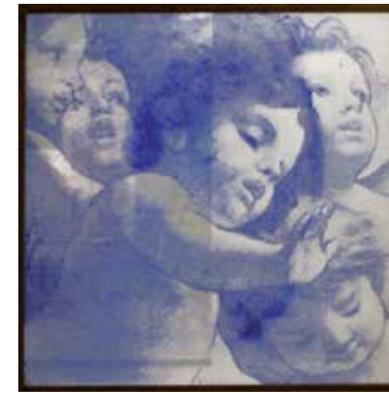
Blue screen print

The image was broken down into its three basic colours with the help of computer programmes. Then the three colours were screen-printed onto the three glass panels (2 mm). Fine-tuning of the size of the screen dots and the colour impression was carried out on sample panels. The screen should not be too fine, so that the copies are visible to the viewer as contemporary reconstructions.

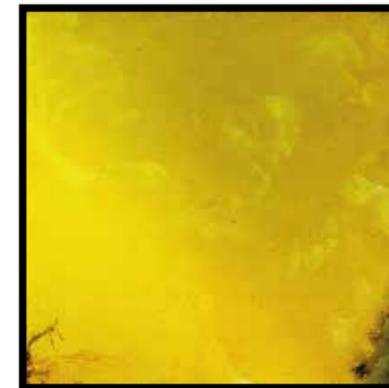
Yellow screen print

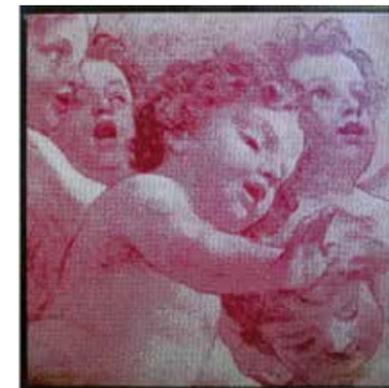
Red screen print

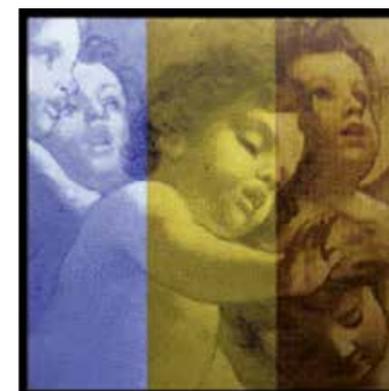
Pane structure

The stained-glass windows, executed with this technique without painting, appear in transmitted light like oil paintings with the finest glazes. Three flashed glass panes in the primary colours red, blue and yellow were used to produce these windows. The designs were transferred to the glass by means of a multi-stage etching process.

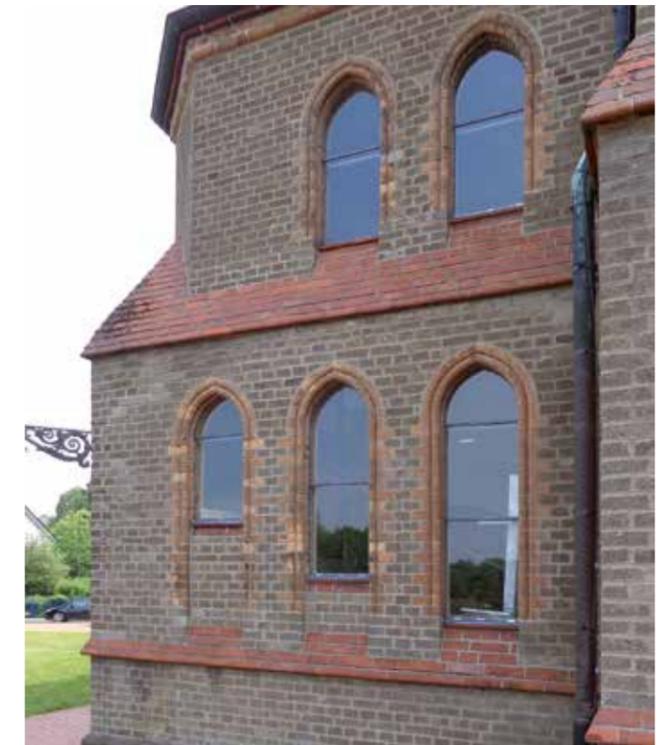
Closure of the building envelope by the protective glazing - the art glazing is simply placed in front from the inside after restoration.

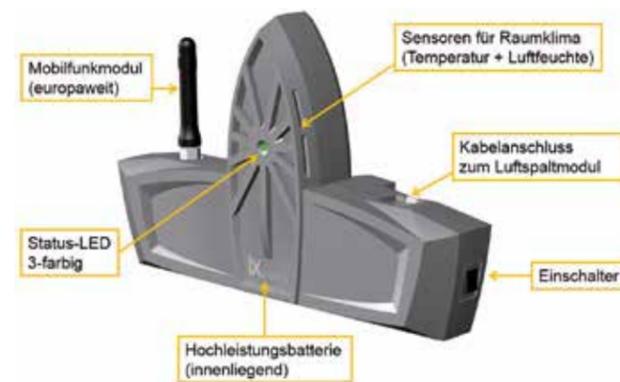
Main sensor module (front)

- Contact-free measurement of glass surface temperatures (protective glazing, stained glass in the interspace, stained glass in the interior)
- Non-contact measurement of wall temperature

- Emission levels of the surfaces to be measured freely adjustable
- Measurement of relative humidity and temperature in the interspace and the interior

- Measuring range: -20°C to 85°C, measuring accuracy > 99.5
- Measurement data acquisition at 15-minute intervals
- Daily transmission of measurement data to the secure web server via the mobile phone network Europe-wide (no WLAN required)

- All measurement data can be downloaded as a CSV file
- Energy self-sufficient for at least one year
- Simple plug & play installation (no configuration required)

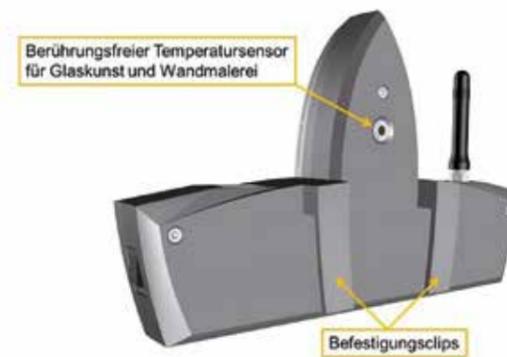
Main sensor module (back)

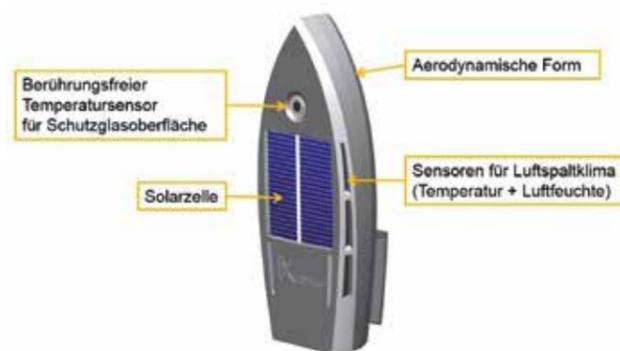
Luftspaltmodul (Vorderseite)

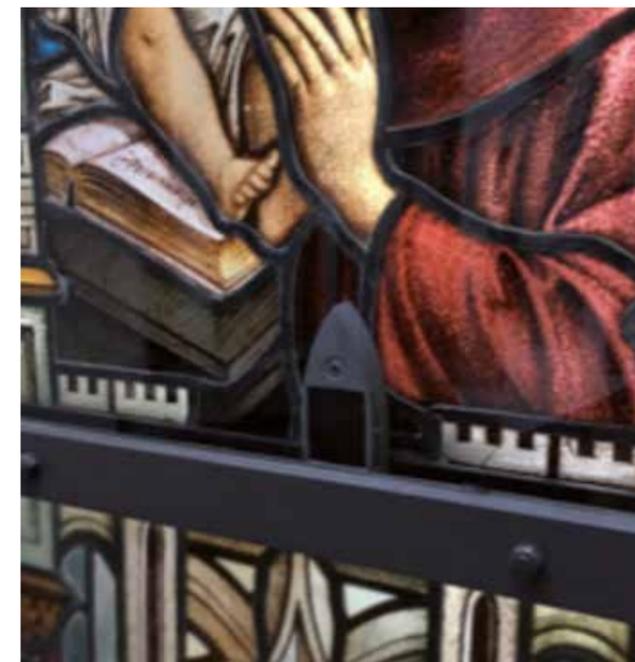
Installation situation interspace module

The sensor system records climate data in the interspace between the protective glazing and the stained glass as well as in the interior of the church, which is necessary to monitor the functionality of the protective glazing. The measurement data is recorded for at least an entire calendar year and transmitted daily via the mobile phone network to a password-protected internet platform. All data is automatically processed and made available in the form of clear diagrams which can be accessed anywhere in the world via an Internet browser.

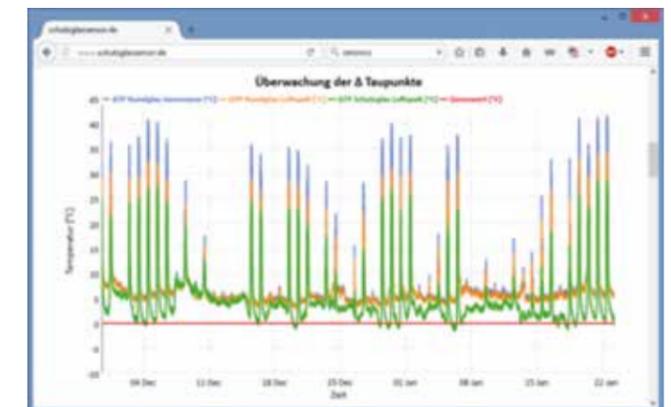
Measurement data diagrams in the Internet portal

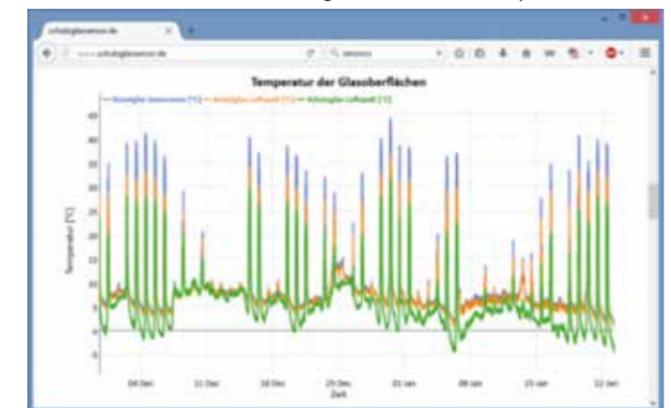
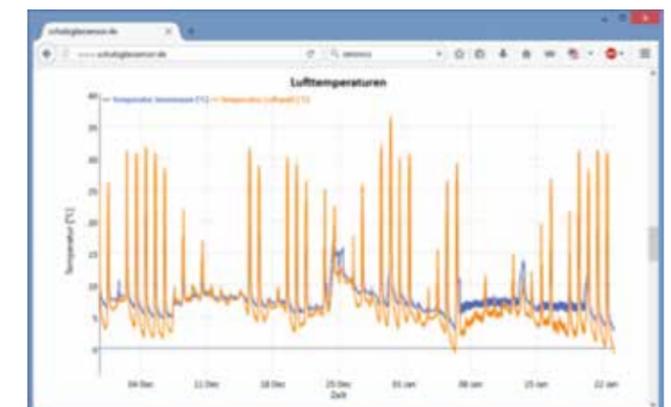
The sensor system is optimally adapted to the structural and climatic conditions of protective glazing.

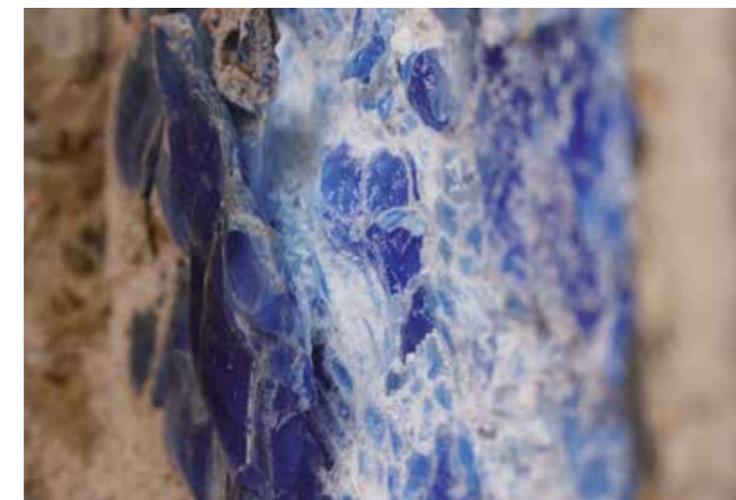
Chipped glass surface
