# GLASMALEREI PETERS STUDIOS

Studios for restoration and preservation of historic monuments

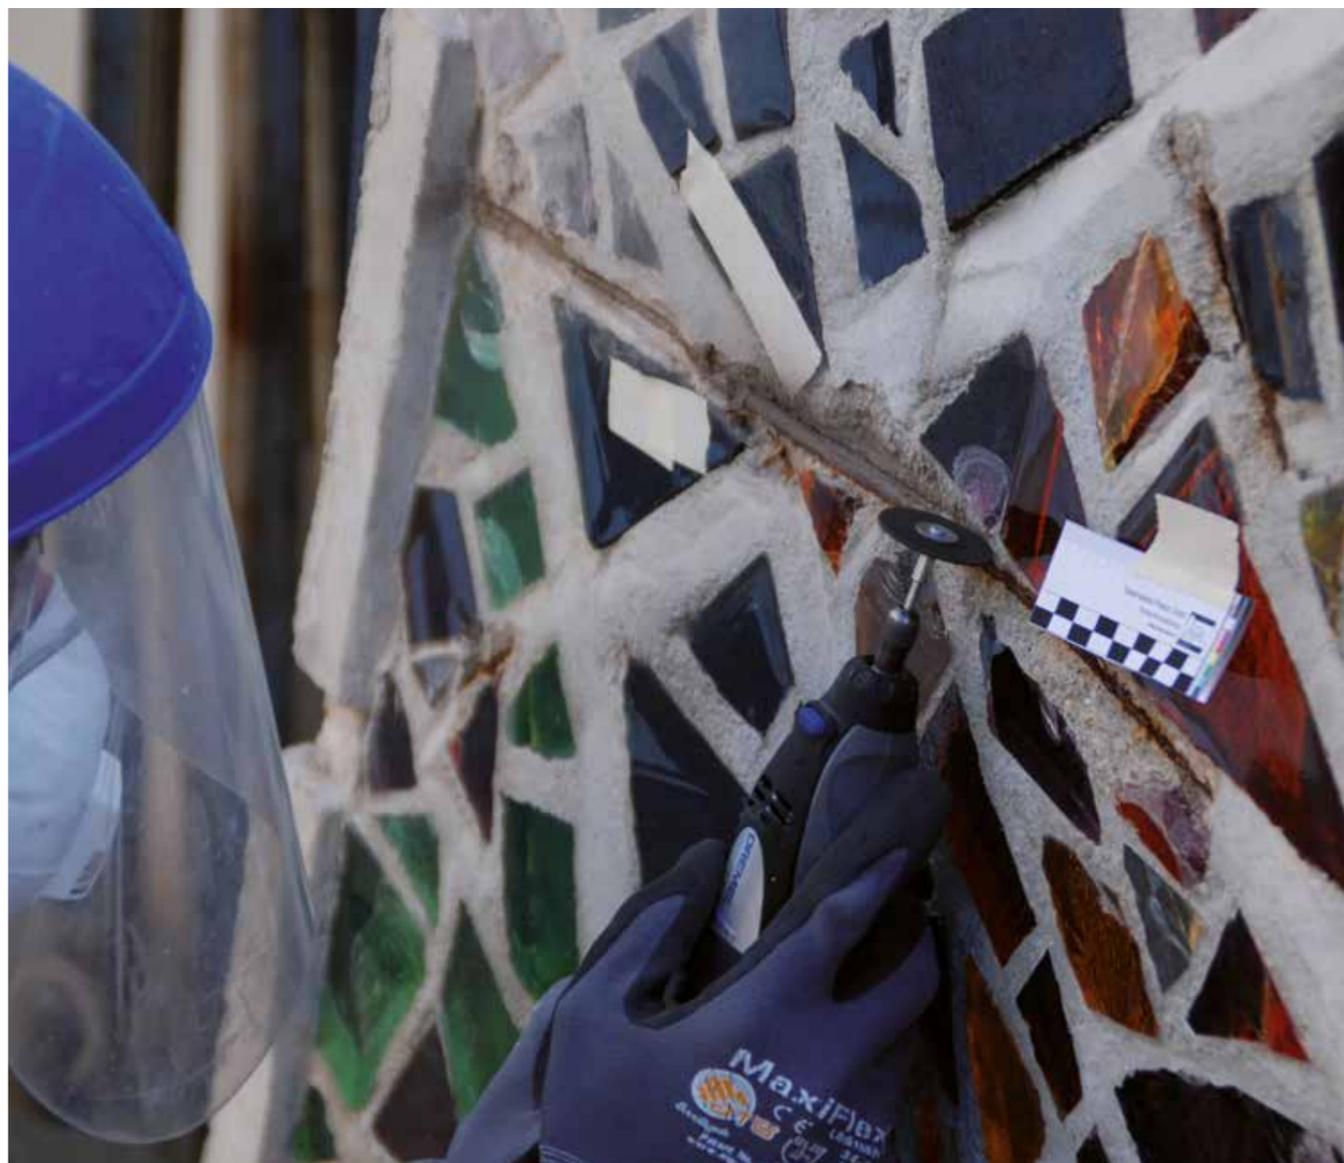
38 Exposure of the corroded reinforcement bars - Neustadt am Rennsteig

Protecting the windows with a cathodic corrosion protection system is also part of our restoration expertise. We are constantly working on optimising and improving the existing restoration techniques.

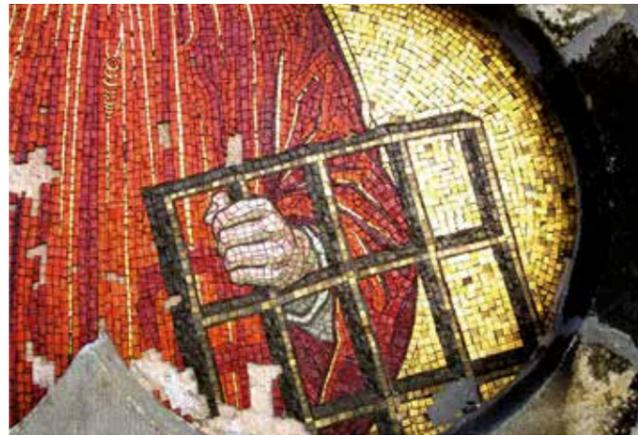
Damaged mosaic

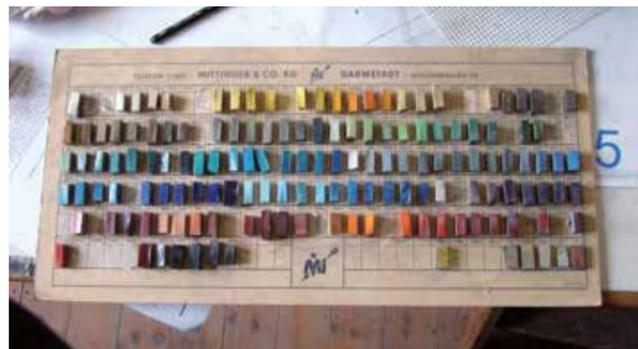
Mosaic sample tesserae

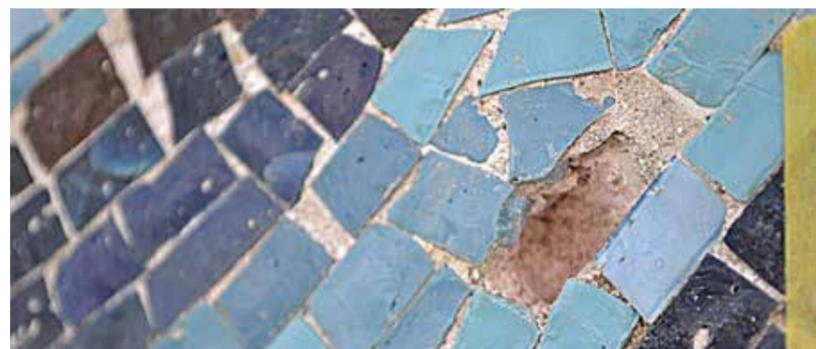
Defective areas

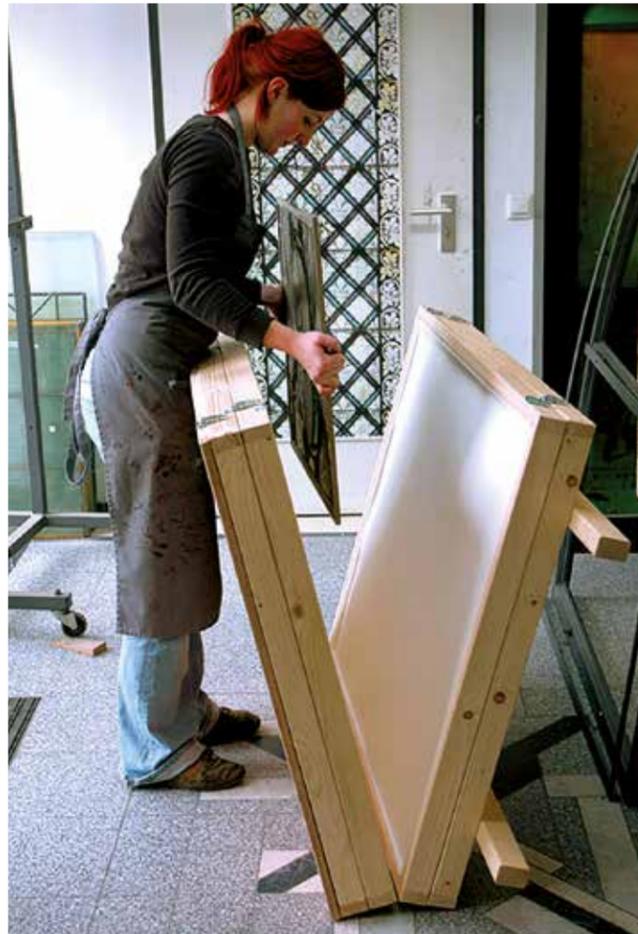
42 *Transport crates specially made for the project*

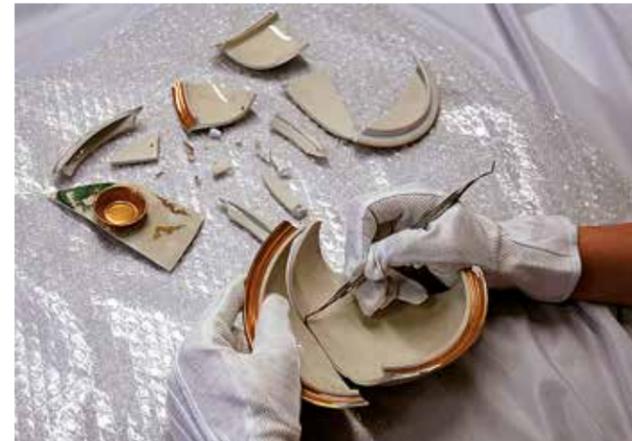
*Preparation of areas to be glued*

Hollow glass, as well as small ceramics and lamp glasses, can also be restored and conserved by our specialist staff. Historical vessels from collections and archaeological excavations must be permanently secured and conserved. Here it is necessary to go into the third dimension.

The conservation of these glass vessels confronts our conservators with a completely different set of challenges, as the damage here is sometimes more strongly related to the mixing and production technique, or to the special storage of the objects in showcases or in the ground.

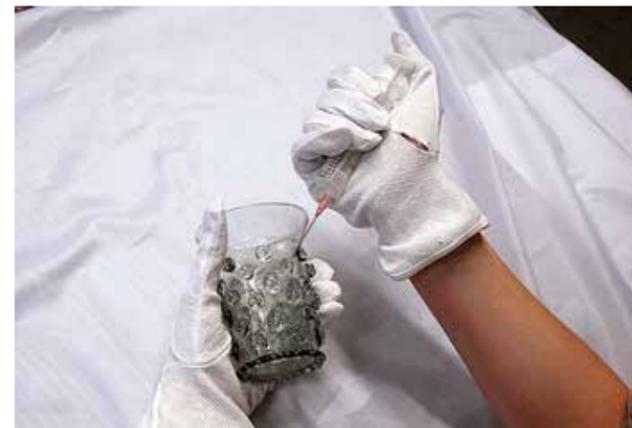
*Filling in the adhesive*

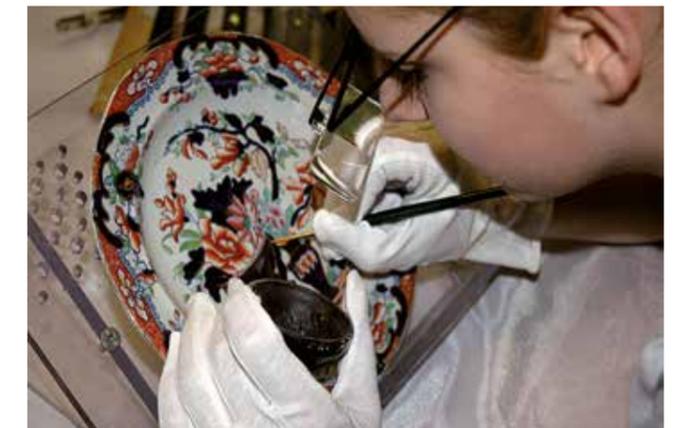
*Retouching the bonding with the help of magnifying glasses*
